# CASE STUDY – ACOUSTIC EMISSION TESTING

## DUBAI AIRPORT – 16” BURIED JET FUEL PIPELINE LEAKAGE DETECTION

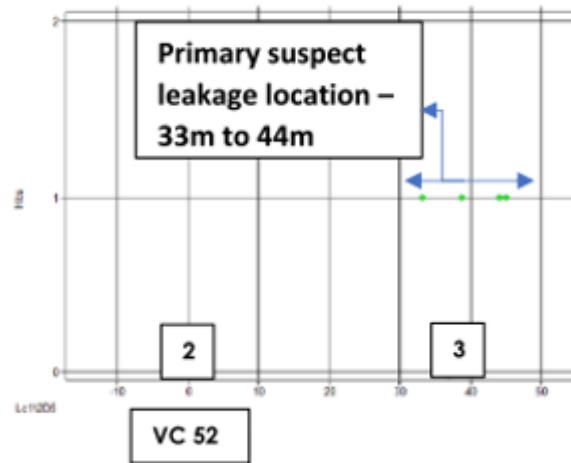
**FIG.5 – Detected Leakage Location**

As per the acoustic emission inspection data analysis, primary suspect leakage location was found between 33m to 44m from Valve Chamber (VC) 52 and was reported to client

Client excavated the identified area by acoustic emission testing and the leakage location was found. The leakage was repaired quickly, and normal airport operations were restored.

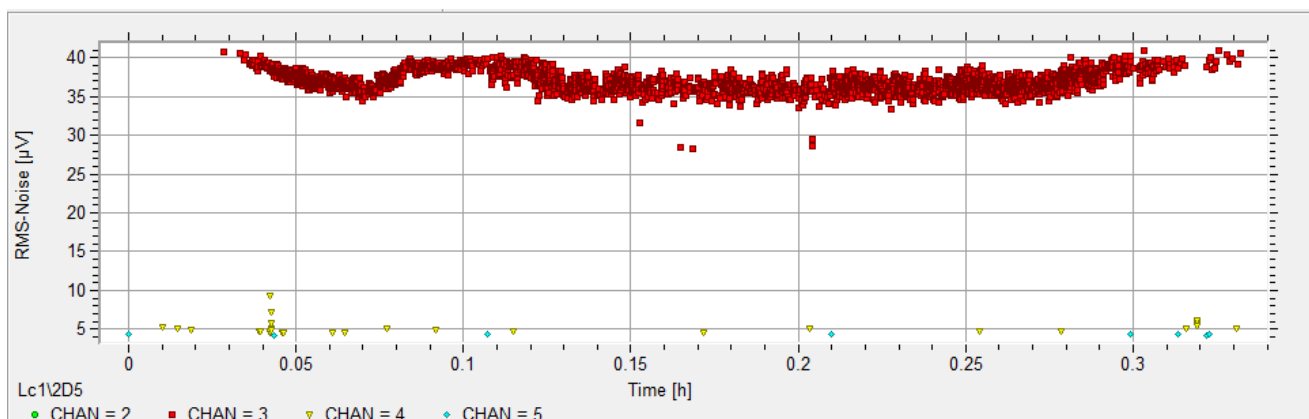
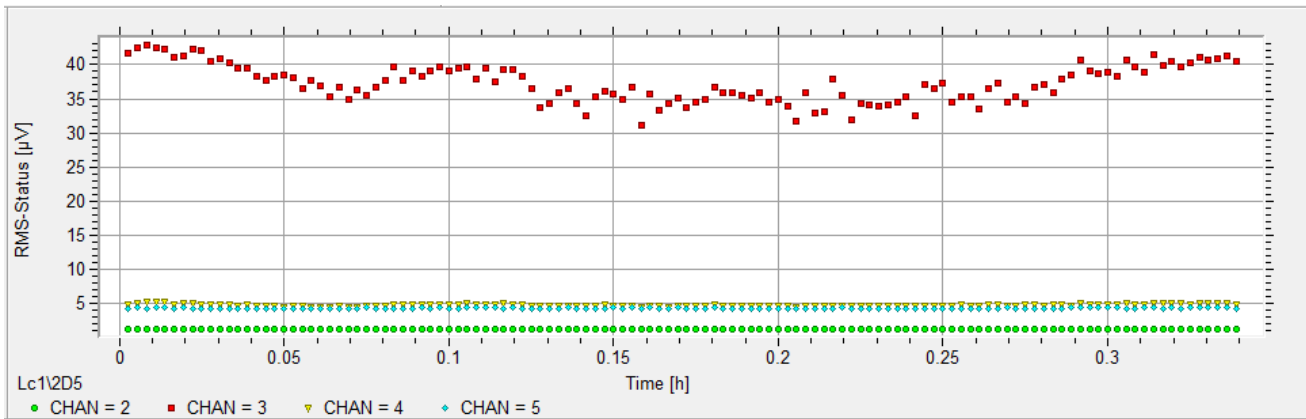
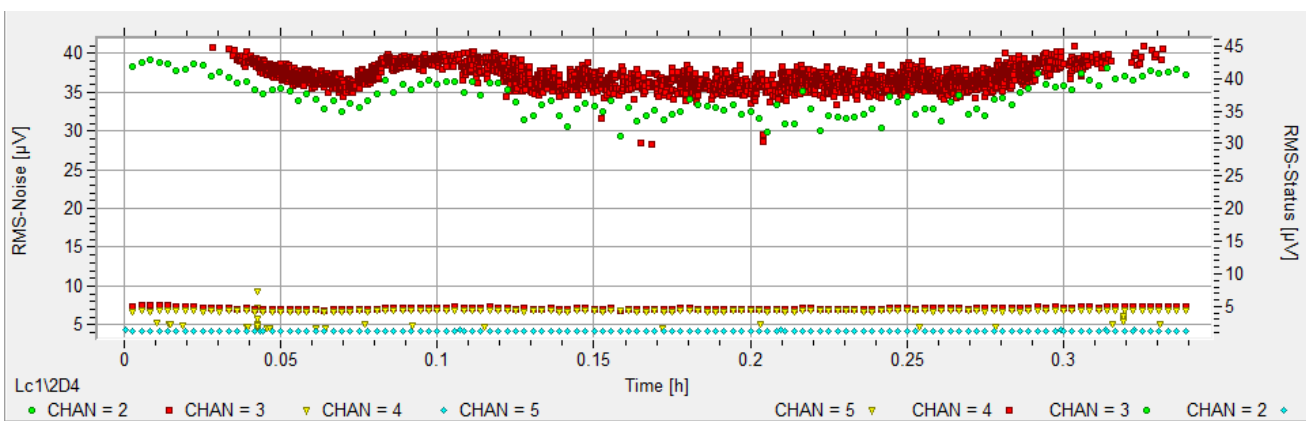
**Figure A, B & C: DEFECT ACTIVITIES NEAR EACH CHANNEL.**

The above graphs indicate the response from each sensor with respect to the time. As shown, the Acoustic Emission activities from the sensor 3 (CHAN =3) are higher, that clearly indicates the presence of defect near that sensor location. When closely analysing the signals, the primary suspect was found to be between 33m to 44m in the pipeline from Valve Chamber (VC) 52.
