CASE STUDY – ACOUSTIC PULSE REFLECTOMETRY

FPSO (Ghana)

Boiler & Suction Cooler Tube Inspection

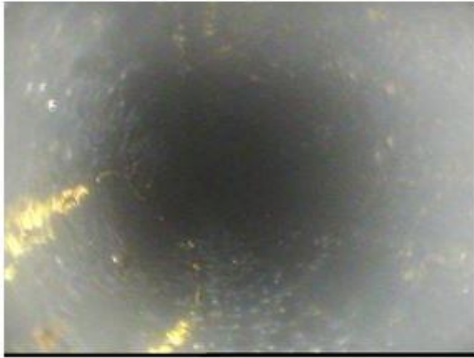
Erosion

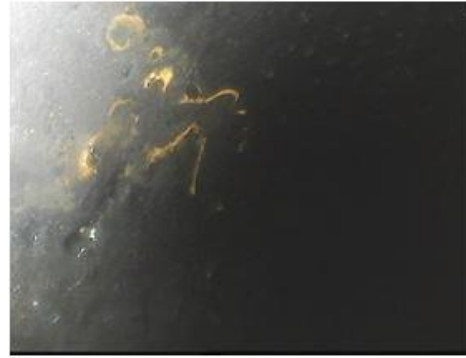
Pitting

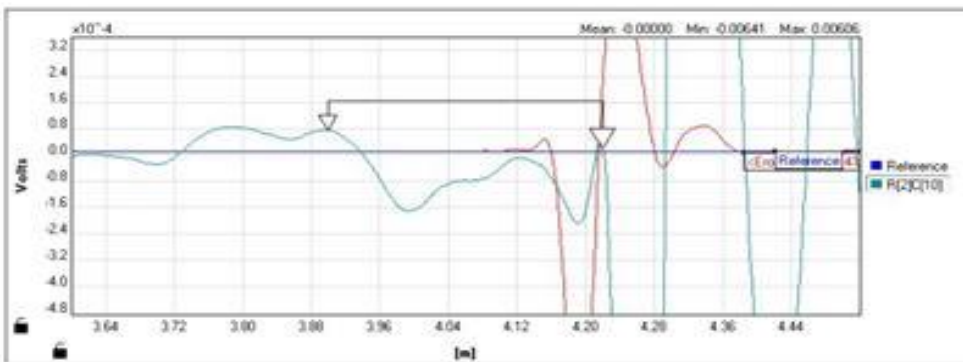
>> Erosion

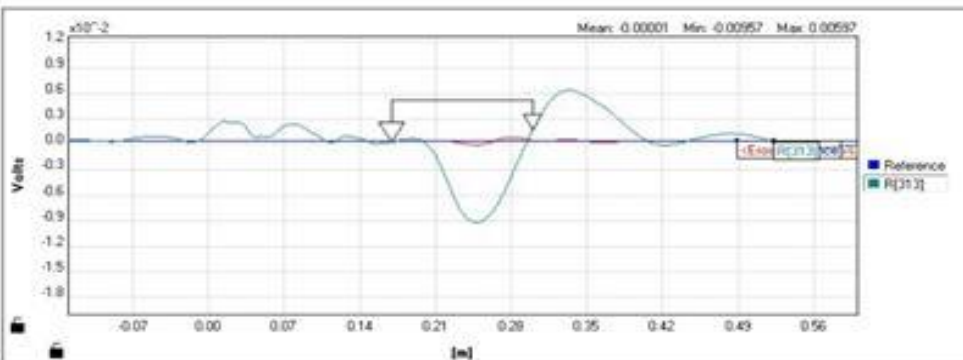
>> Pitting

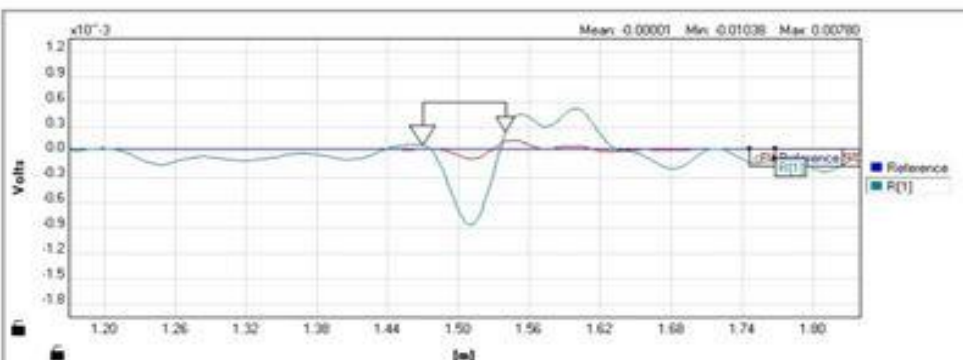
>> Pitting
