CASE STUDY – Flare Header Pipeline Integrity Assessment

42" Flare Header Pipeline

Job Overview

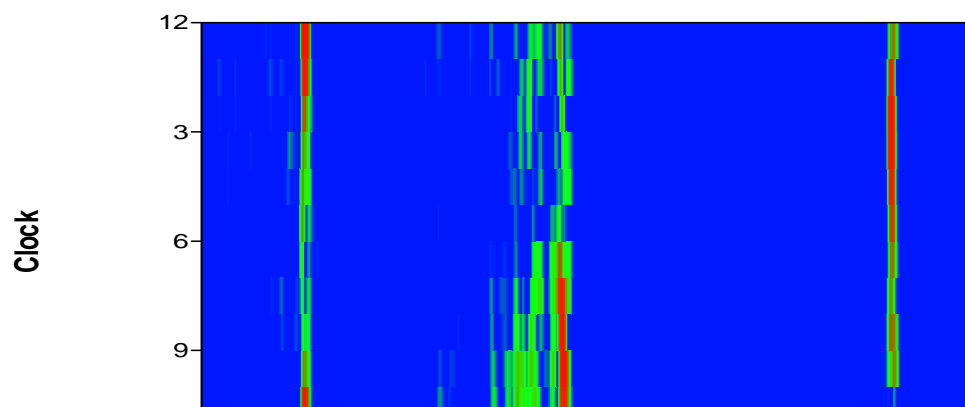
Result: 1

Feature	Location	ECL	Length	Extent	Class	Clock	Notes
-F9	-10.11	2.7	1.38	0	Severe		D12. AUT scanning is recommended along
-F6	-6.82	2.2	0.25	0	Severe	4	D13. AUT scanning is recommended along
-F3	-5.31	13	0	0	Medium	3	D14. Non-symmetry in the weld. Weld
+F3	4.54	46	0	40	Medium	2	D15. Non-symmetry in the weld. Weld
+F5	7.22	9	0	30	Medium	7	D16. AUT scanning is recommended along

Fig 5: GWUT analysis finding & signals

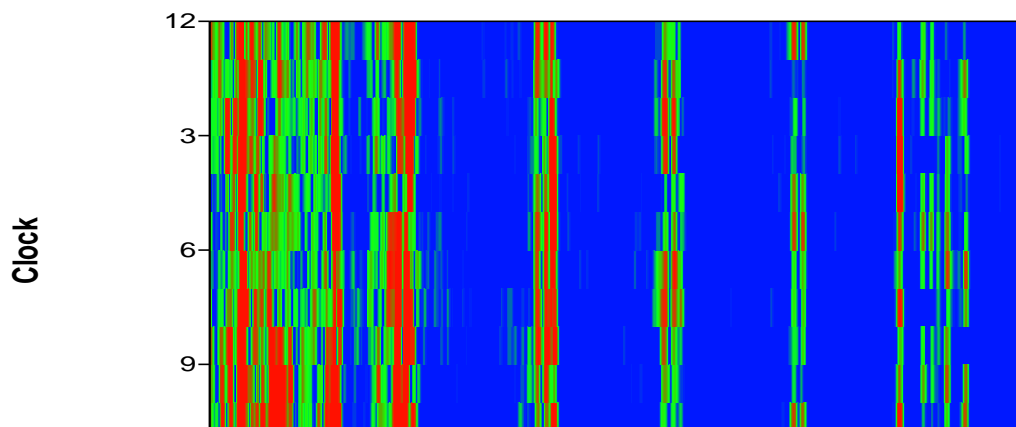
Result: 2

Feature	Location	ECL	Length	Extent	Class	Clock	Notes
-F25	-20.06	3.5	0	14	Severe	9	D28. AUT scanning is recommended along 500mm of this point
-F21	-16.42	1	0	0	Severe	8	D29. AUT scanning is recommended along 500mm of this point
-F13	-10.79	3.3	0	19	Severe	8	D30. AUT scanning is recommended along 500mm of this point
-F9	-7.23	2.3	0	16	Severe	4	D31. AUT scanning is recommended along 500mm of this point
-F4	-2.68	2	0	5	Severe	4	D32. AUT scanning is recommended along 500mm of this point
+F11	10.34	1.7	0	0	Severe	4	D33. AUT scanning is recommended along 500mm of this point
+F14	15.49	1.9	0	12	Severe	7	D34. AUT scanning is recommended along 500mm of this point
+F21	21.21	3.2	0	0	Severe	11	D35. AUT scanning is recommended along 500mm of this point

Fig 6: GWUT analysis finding & signals

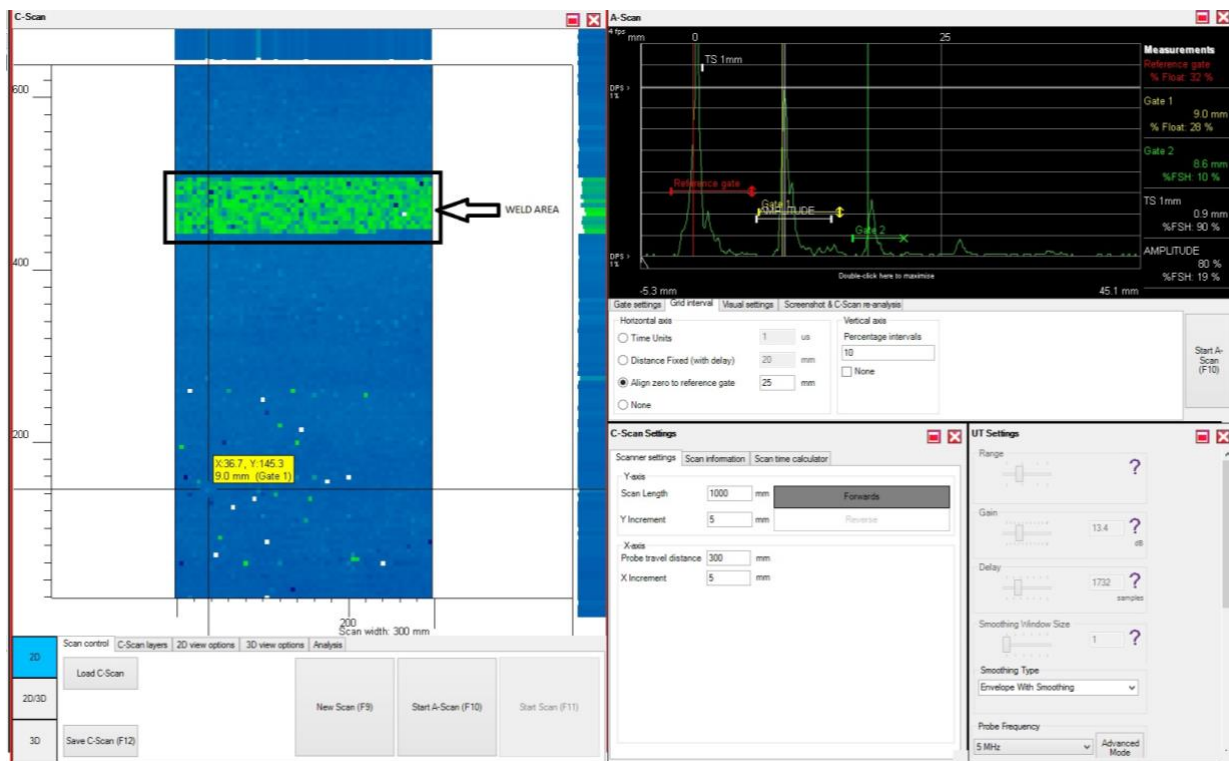
Result: 1

Fig 8: AUT analysis finding & signals

- ✚ Average and sever wall loss was found due to internal/ external general corrosion & pitting.

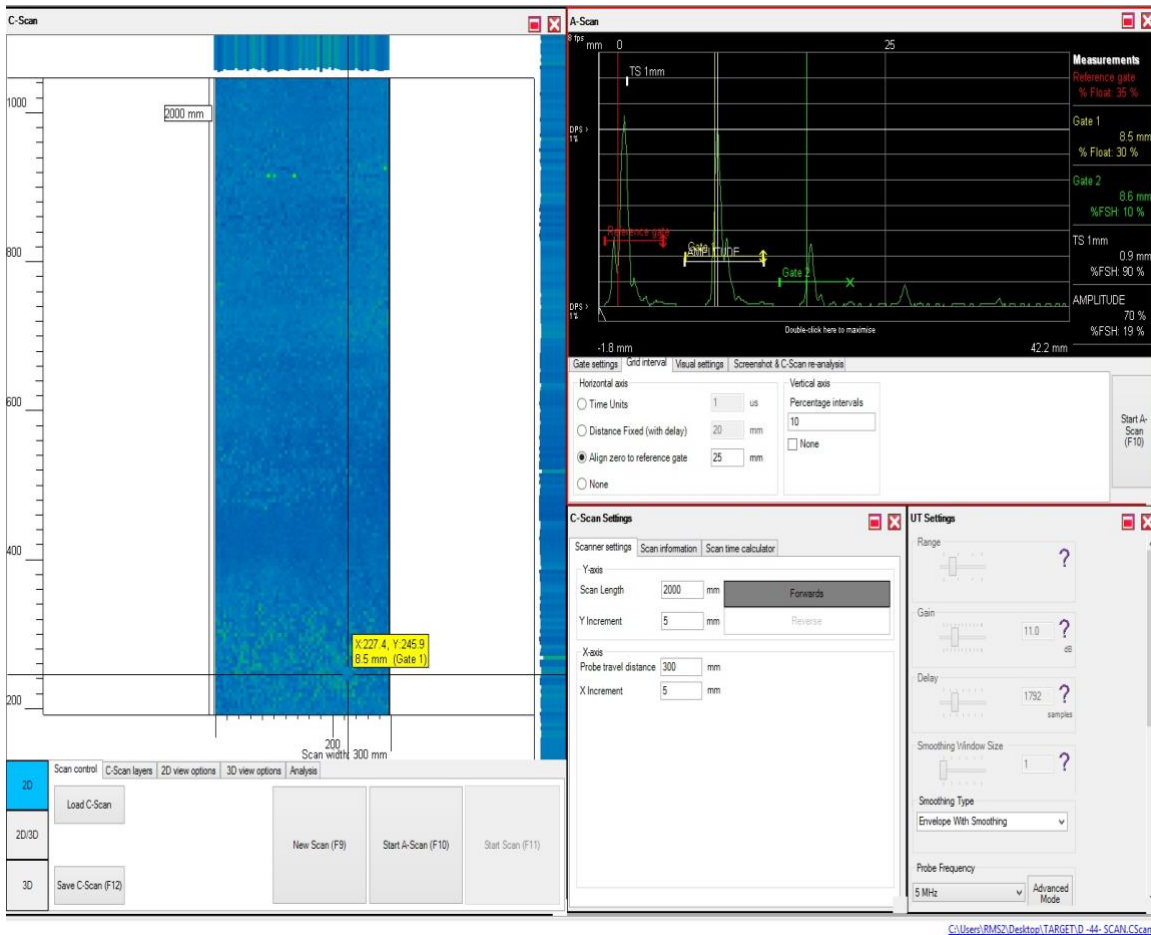
Result: 2

Fig 9: AUT analysis finding & signals

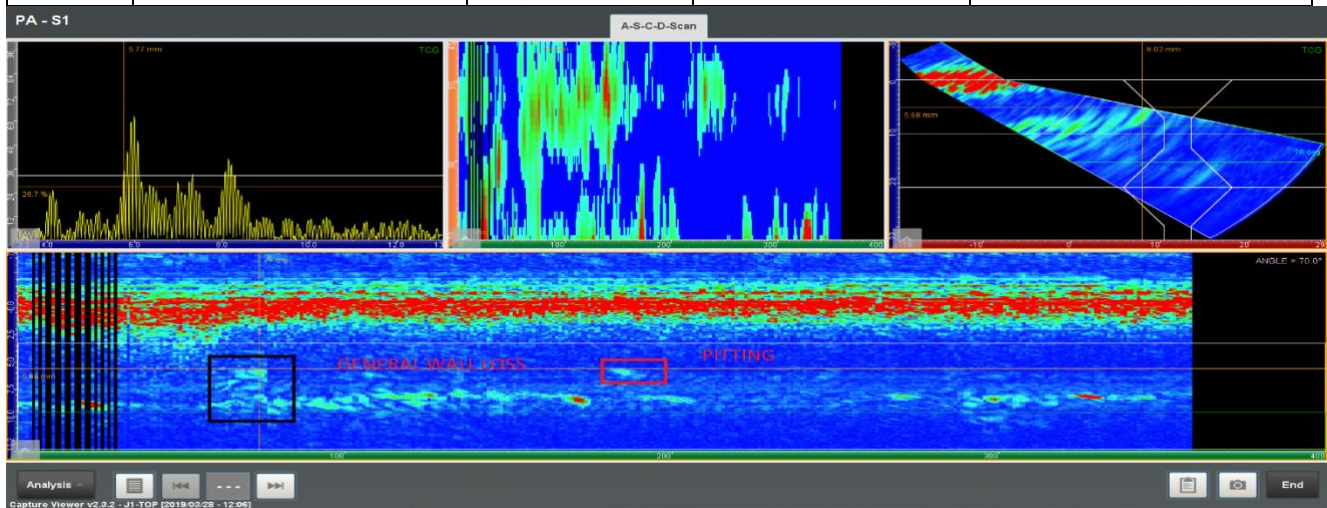
Result: 1

Sr. No	Defect Type	Length	Minimum Thickness	Defect Location
1	CORROSION	30 mm	5.6 mm	11 O' clock
2	ISOLATED PITTINGS	SPOTS	5.2 mm	All around

Fig 12: PAUT analysis finding & signals

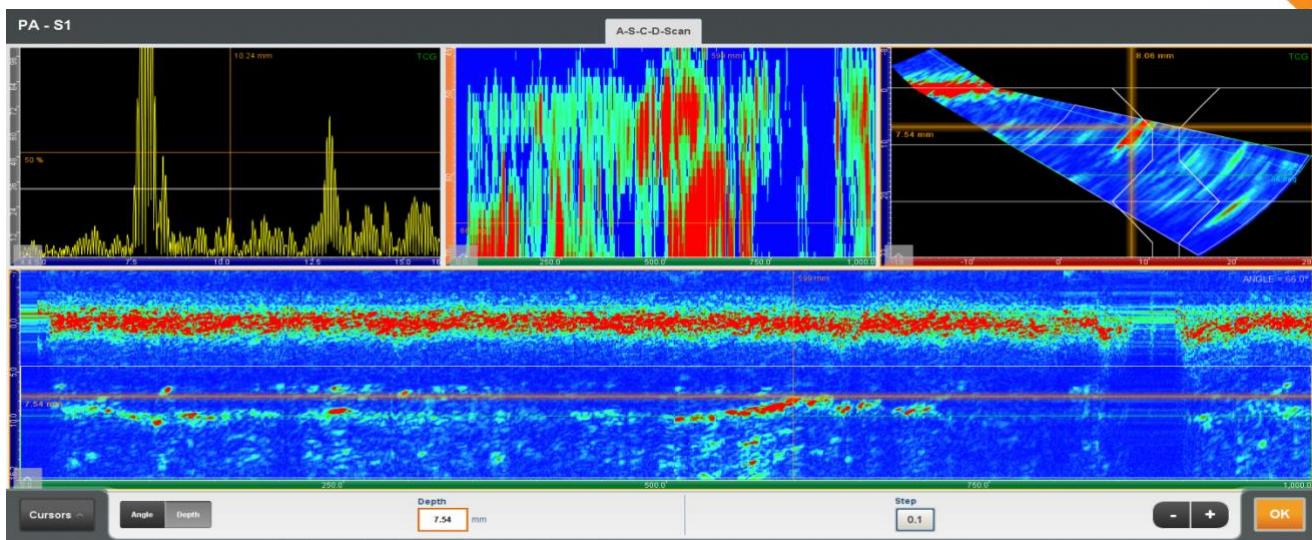
Result: 2

Fig 13: PAUT analysis finding & signals

- ✚ Minimum measured wall thickness was 4.6 mm.
