CASE STUDY – ACOUSTIC EMISSION TESTING

16” BURIED PIPELINE CORROSION AND LEAKAGE DETECTION

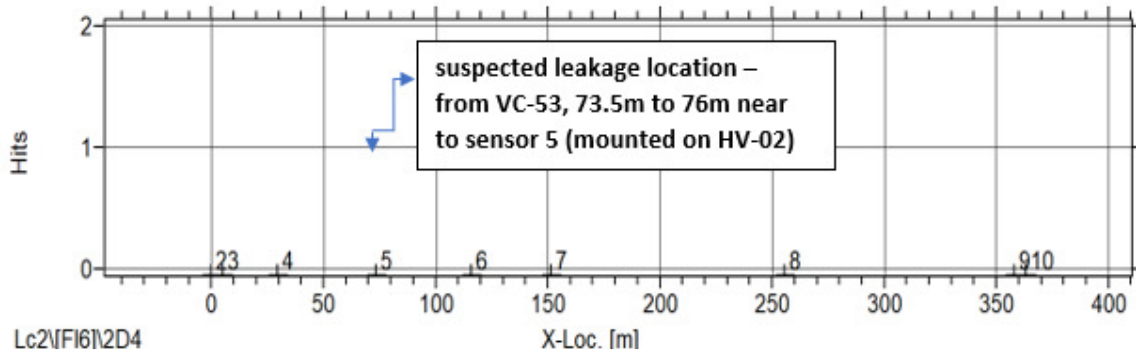
FIG.5 – Detected Leakage Location

As per the acoustic emission inspection data analysis, suspect leakage location was found between 73.5m to 76m from Valve Chamber (VC) 53(mounted on HV-02) and was reported to client

1. The suspect leakage location was found to be between 73.5m to 76m in the pipeline from Valve Chamber (VC) 53.
2. The corrosion activities were found at the area near to Valve Chamber (VC) 50.
3. The suspected valve passing/ leakage activities was found at Valve Chamber (VC) 50.

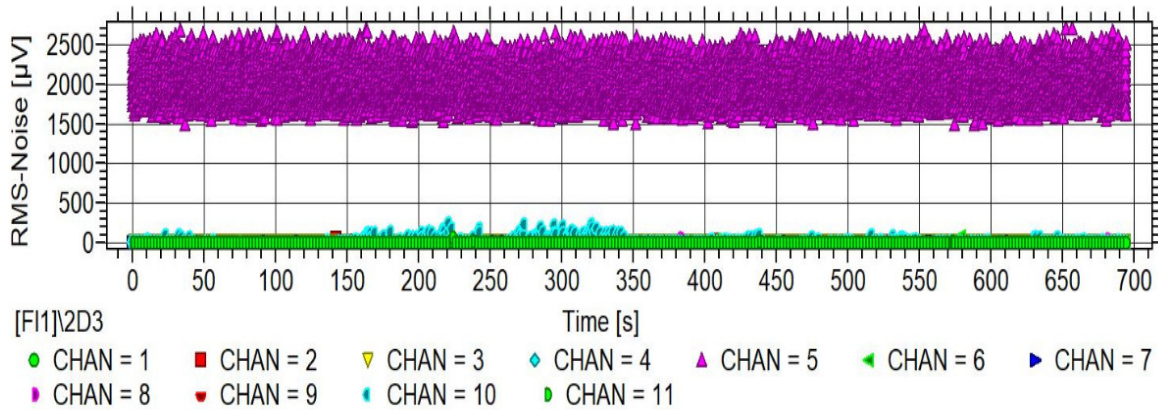
Figure A & B: DEFECT ACTIVITIES NEAR EACH CHANNEL.

The above graphs indicate the response from each sensor with respect to the time. As shown, the Acoustic Emission activities from the sensor 5 (CHAN =5) are higher, that clearly indicates the presence of defect near that sensor location. When closely analysing the signals,
