CASE STUDY – ACOUSTIC EMISSION TESTING

PRESSURE VESSEL

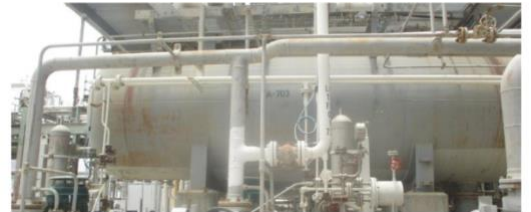
Fig 1: Pressure Vessel

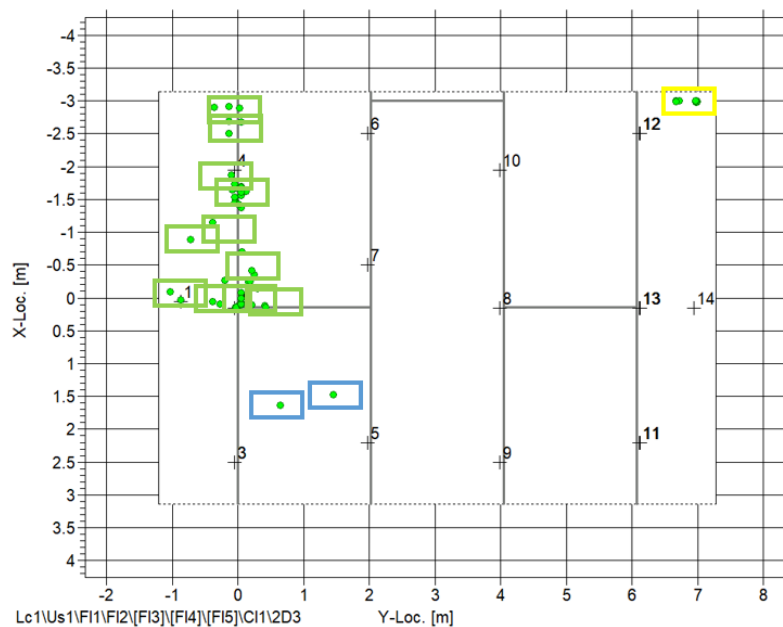
Fig 6: 2D Diagram of significant AE activity locations with severity at maximum operating pressure

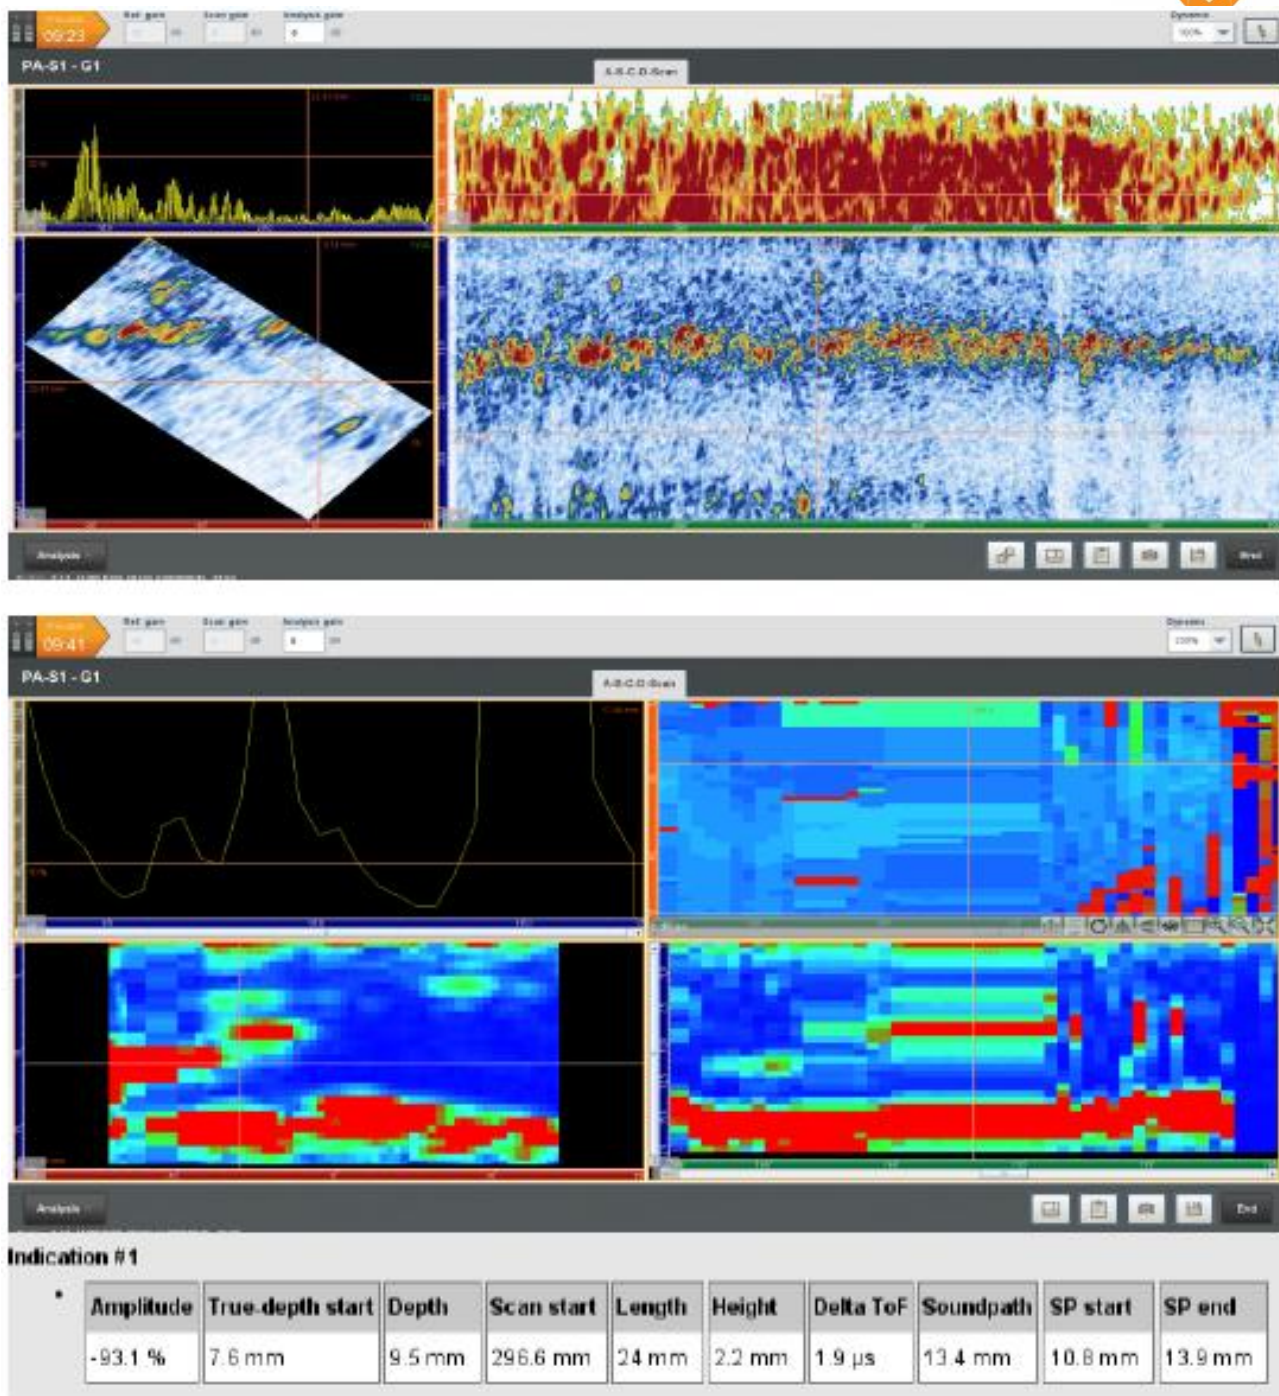
Fig 6: Screenshot of crack detected by PAUT on dish head between blisters (After CS4, 9 O' clock position)
