**PRESSURE VESSEL**

**Job Overview**

At the end of year 2018, ACFM inspection on 2 Polybed PSA Unit Adsorber and on pipeline weld joints was carried out.

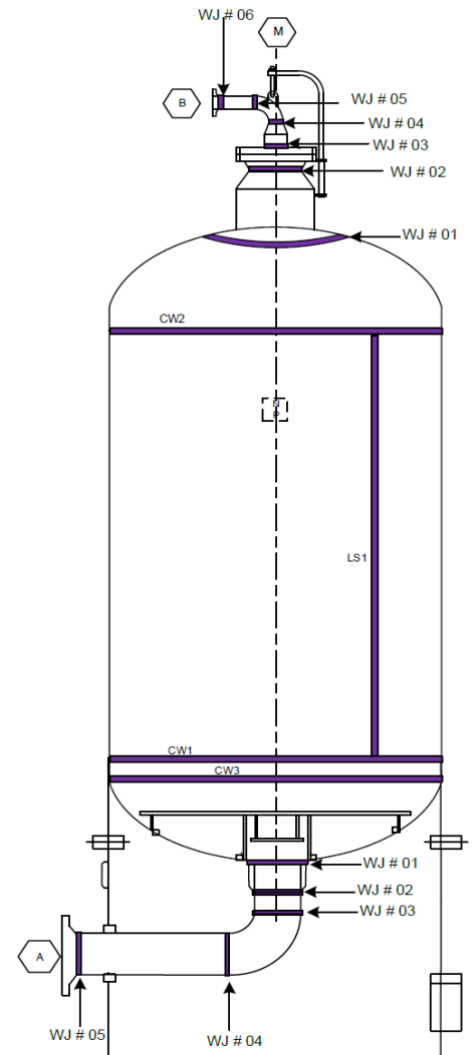
**Fig 1: Pressure Vessel**

<b>Item Name</b>	POLYBED PSA UNIT ADSORBER
<b>Material</b>	Carbon steel
<b>Last Inspection</b>	2017
<b>Inspection Done</b>	2018

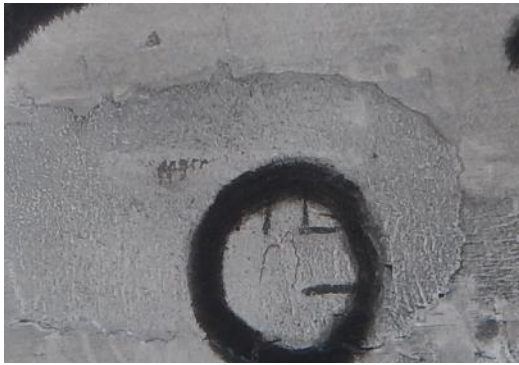
**Fig 4: MPI defect signal**

Client decided to verify the defect location with MPI, paint was removed at the location and magnetic particle inspection was carried out and the defect was confirmed. Below images shows the findings during MPI.

Crack defect indication was found on CW-1 weld during the time of inspection and verified by magnetic particle inspection.

It is recommended that periodic in-service ACFM inspection should be continued for the equipment welds, to detect any new onset of cracks.
